# St. Catherine Parish Church

## Zejtun

### Restoration Method Statement

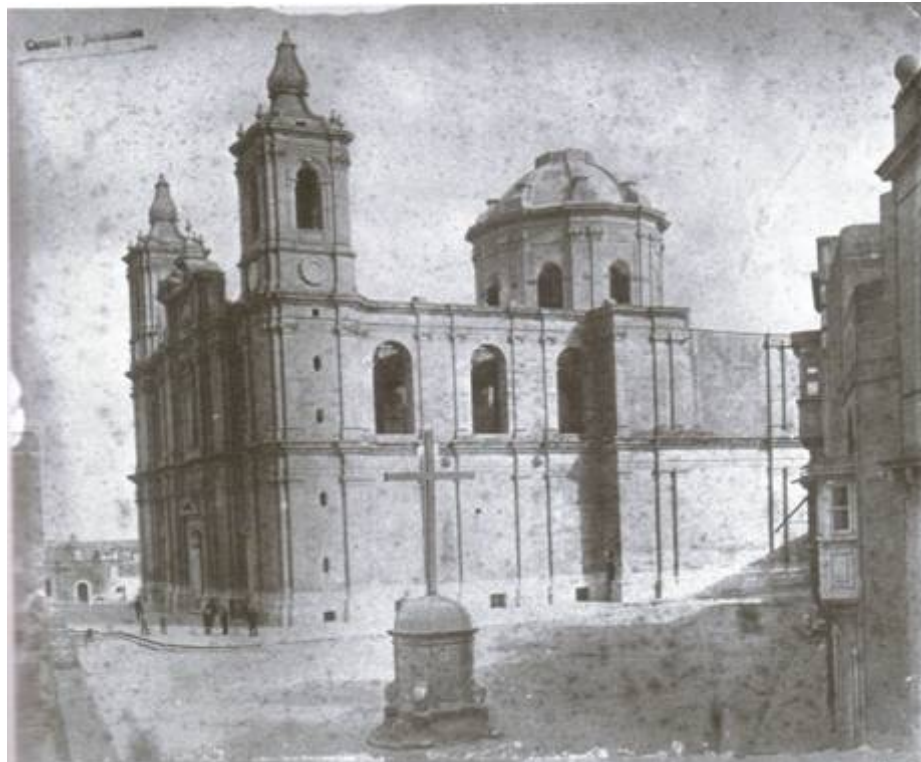
**Plate 2 – Gafa's saucer dome without lantern prior to 1907. Note also the incomplete upper cornice at the back**

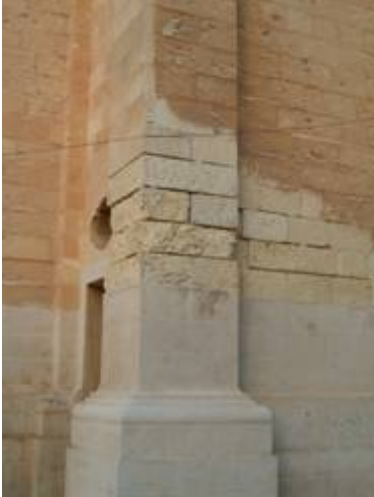
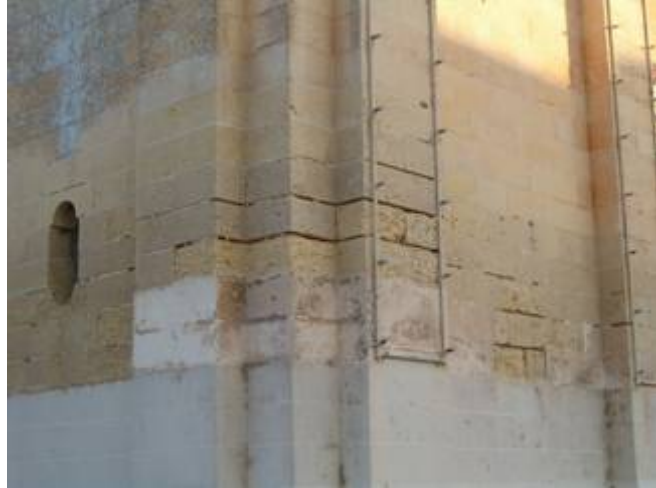
- 4.2 The lower eight courses of the church façade were rendered with a **cement** based plaster in the early 1960s. At some areas this rendering reached also levels up to ten courses above the parvis level. The cement based plaster was applied in a very consistent and dense manner. As a result of this plaster, at certain areas along the facades, dampness rose above the rendered areas and is affecting negatively the exposed masonry. This is particularly evident in the foot of the northern bell tower and on the south façade.

- i. **Cement** – Cement is to be removed by hand held non-electrical tools. The stone will be repaired by plastic repair or replaced depending on its condition once exposed.
- ii. **Alveolar, exfoliation and erosion** – Stone to be properly cleaned by distilled water and plastic repaired. When stone is structurally unsound it will be replaced by a stone having same surface dimensions and at least 15cm deep.
- iii. **Losses** – Architectural details which have been lost and can be easily reproduced from other existing evidence will be replaced by new sculptured stone or when possible by plastic repair.

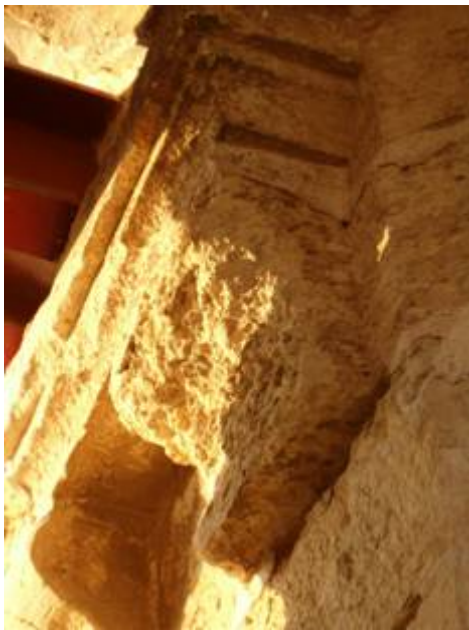
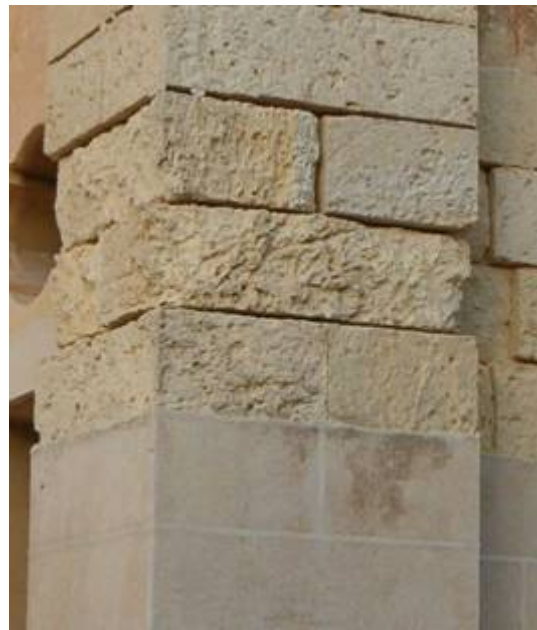
- 4.3 **Alveolar** weathering is evident on certain areas of the façade masonry, particularly where there is high level of rising damp and corner areas which are exposed to wind.

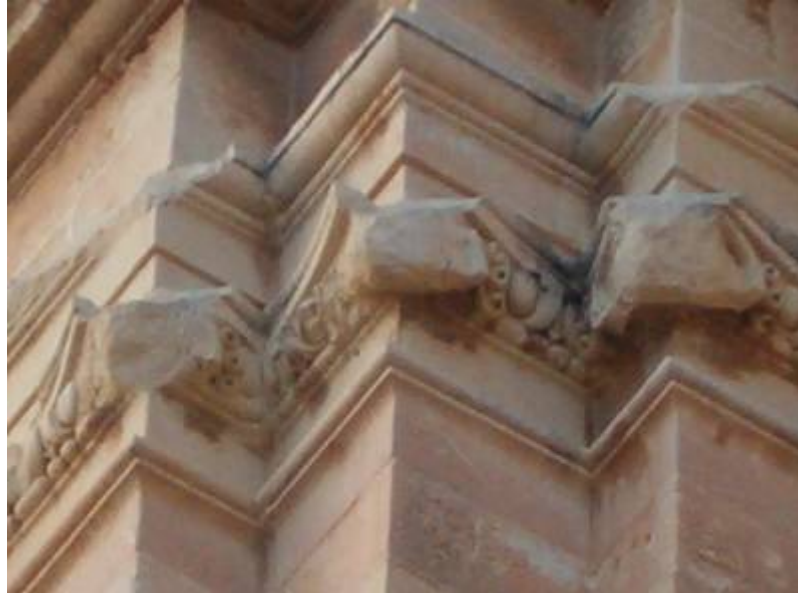
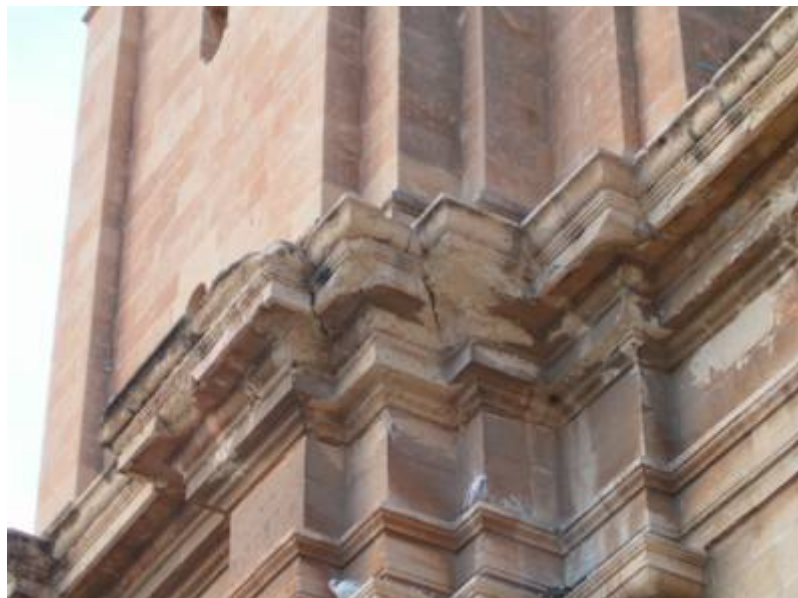
- 4.4 The **erosion** of masonry is found in various parts of the church facades. This is due to various and distinctive factors including

rising damp at the lower parts of the façade, the affect of acidic and salt chemical reactions resulting from superficial deposits below the cornices and wind erosion of sculptured details. Extreme levels of erosion lead to the **loss** of architectural and decorative details and in some parts also extensive parts of the cornices had fallen down.

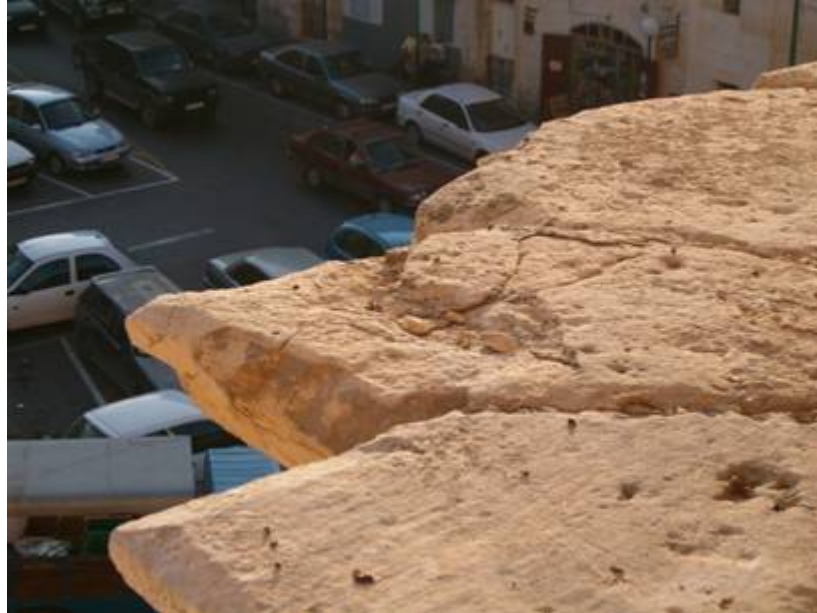
4.5 **Exfoliation** is another deterioration process which was found on the facades of the church. This deterioration process was found both at

lower and higher parts of the facades. In this process the stone literally exfoliates in thin or thick layers. It is also evident on the edges of cornices and other architectural details.

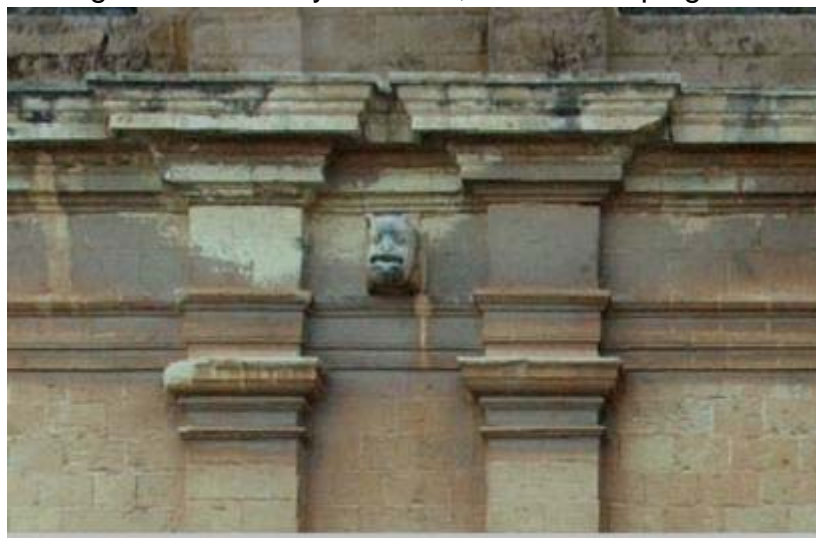
- 4.6 **Superficial deposits** are found in areas which are sheltered from rain. These deposits give a soil brown colour particularly in the areas which are protected by the cornices. Although initially this deposit is not harmful, by time it reacts with the stone through other pollutants and forming acids and salts which will lead to the powdering of the masonry surfaces, later developing into erosion.

- iv. **Superficial deposits, staining and biological growth** – Stone surface to be cleaned by nylon brushes after moistening the stone with distilled water and paper pulp when necessary.

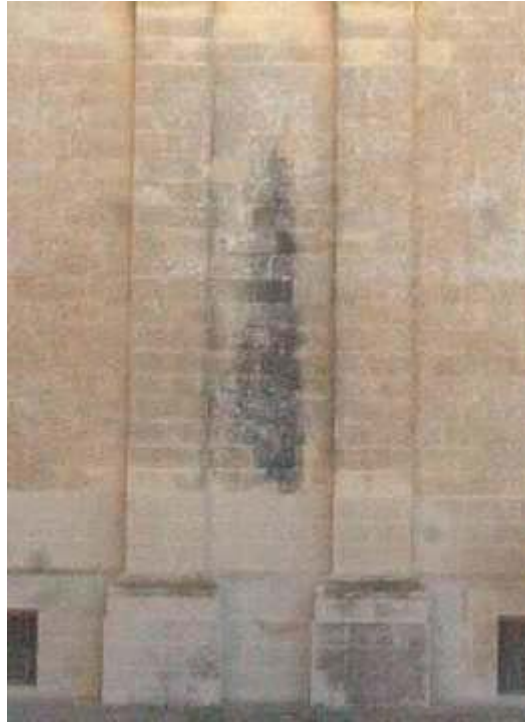
- 4.7 Some areas of the facades are **stained**, mostly due to dripping water or where areas are continuously exposed to dew. This stain

does not pose any harm to the stone except for its negative aesthetic appearance.

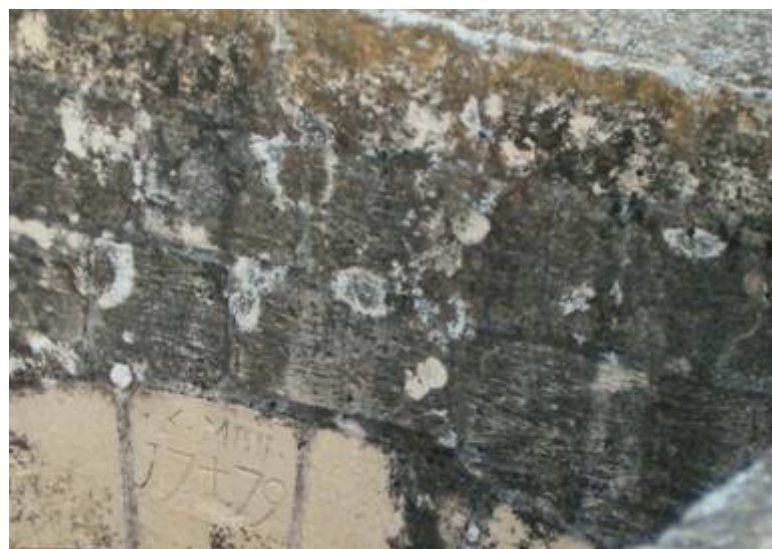
- 4.8 **Biological growth** is not harmful to the stone surface and this is mostly found on areas which are not exposed to direct sunlight. However areas dominated by such growth are considered to be aesthetically unacceptable due to the dark appearance of the stone.

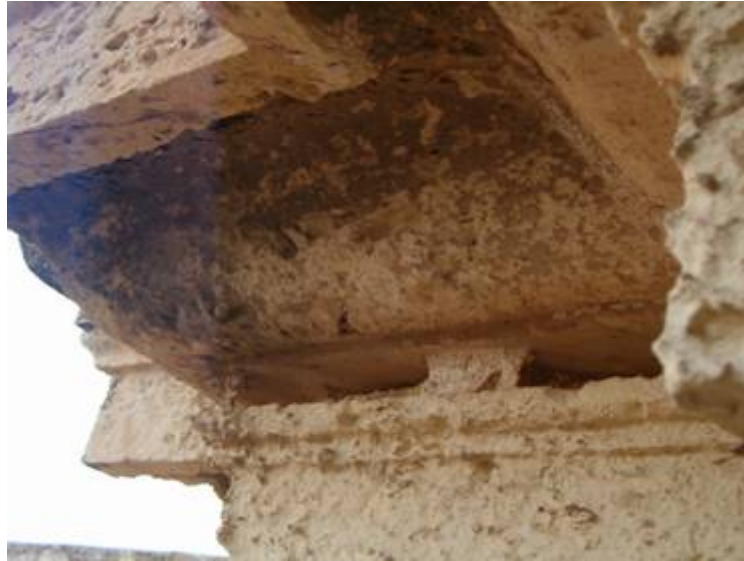
- 4.9 **Black crust** is found under the cornices on areas which are not visible on elevation. Black crust is formed up by the setting of

pollutants on the stone surface and later on reacts with the stone and erodes the stone.

- v. **Black crust** – will be cleaned after moistening by paper pulp and distilled water using nylon brushes and surgical blades. In certain areas where and when necessary, micro blasting at controlled pressure using glass bubbles will be used. A lime wash (*velatura*) will be given after cleaning or toning down of black crust in order to obtain a consistent appearance.

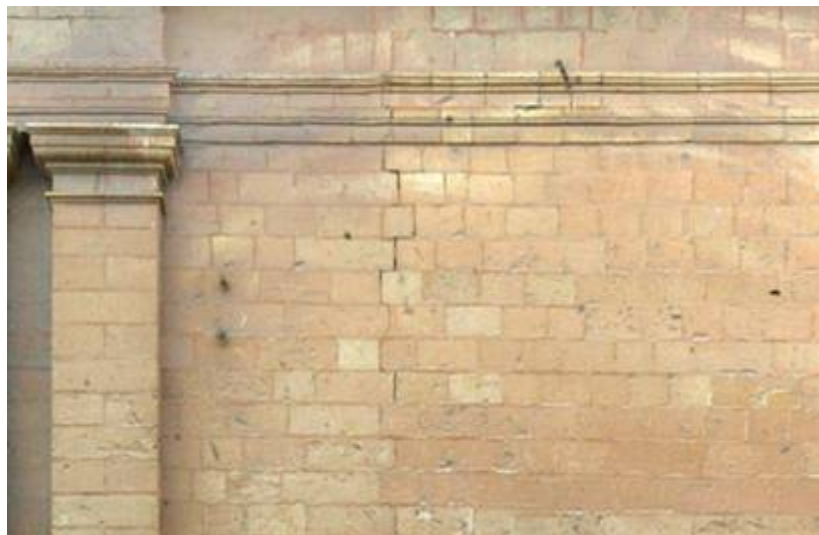
- 4.10 A major structural **crack** was noticed on the south façade, with the crack running from the top part of the façade till the lower parts of it. The crack seems to be an old one and there does not seem to be any more movement.

- vi. **Cracks** – will be re-pointed using lime based mortars. Similarly any weak mortar joints will be raked off and re-pointed using identical mixes in the proportions listed as appendix.

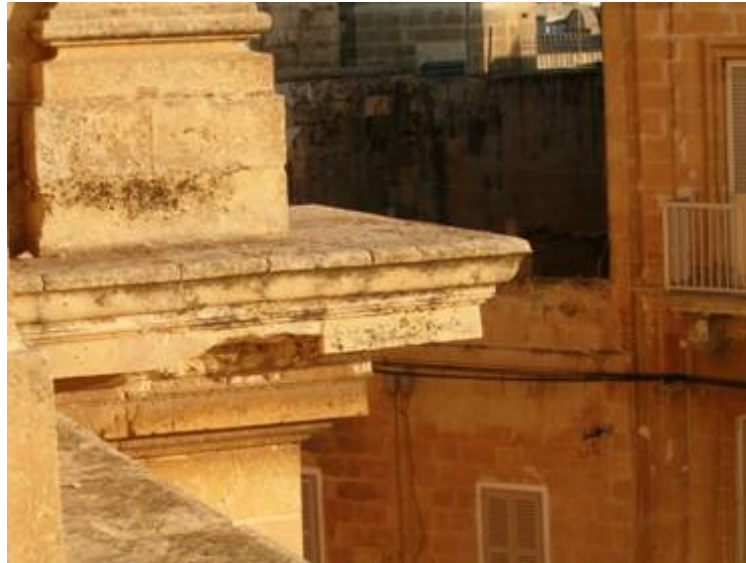
- 4.11 The upper horizontal surface of cornices are not covered with *deffun* and as a result water is setting on these surfaces and

penetrating into the stone and the open mortar joints with the result that these architectural details and the stone underneath are deteriorating at a fast rate.

- vii. **Deffun** – will be applied on all exposed horizontal surfaces in order to protect the stone from water penetration. All surfaces will be laid to falls in order to improve surface runoff.

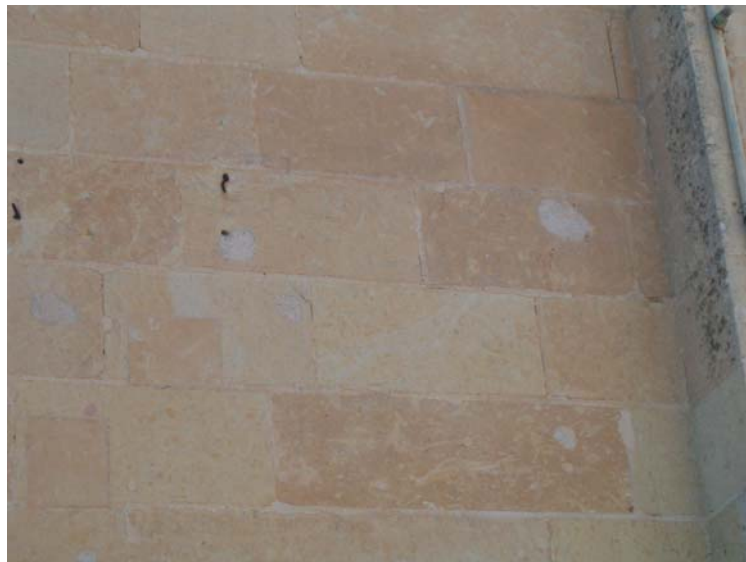
- 4.12 During World War II an anti-personal bomb was thrown by the enemy onto the church parvis and besides leaving a considerable number of victims it also left shrapnel marks on the main façade. Some of these are still visible, whilst others were plastered.

- viii. **Shrapnel marks and graffiti**– will be retained and protected. Those marks which have been plastered over will be cleaned off the plaster in order to retrieve the original shrapnel mark. Any graffiti discovered during the conservation process will be properly documented and at the end of the project will be included in a publication
